Technical Report 587

RESISTANCE OF COATED AND UNCOATED IR WINDOWS TO SEAWATER CORROSION PHASE IV

JD Stachiw (Naval Ocean Systems Center) SL Bertic (San Diego State University) Contract N00123-80-D-0554

1 October 1980

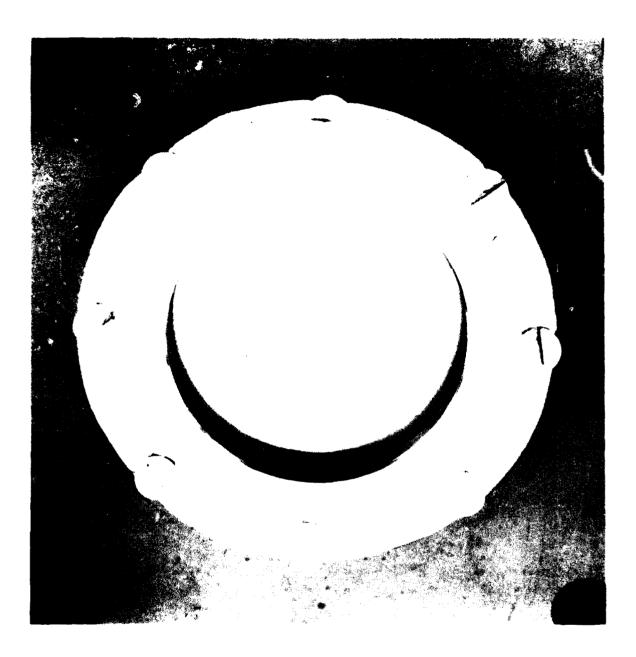
Figure 13. A specimen with the Exotic Materials 40100 AR coating after two months of testing in San Diego Bay.

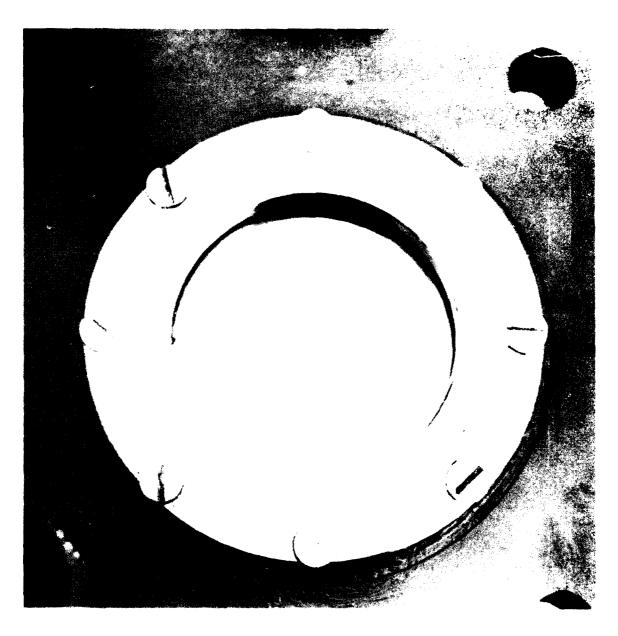
Figure 15. A specimen with the Optic Electronic XF 202 AR coating after two months of testing in San Diego Bay.

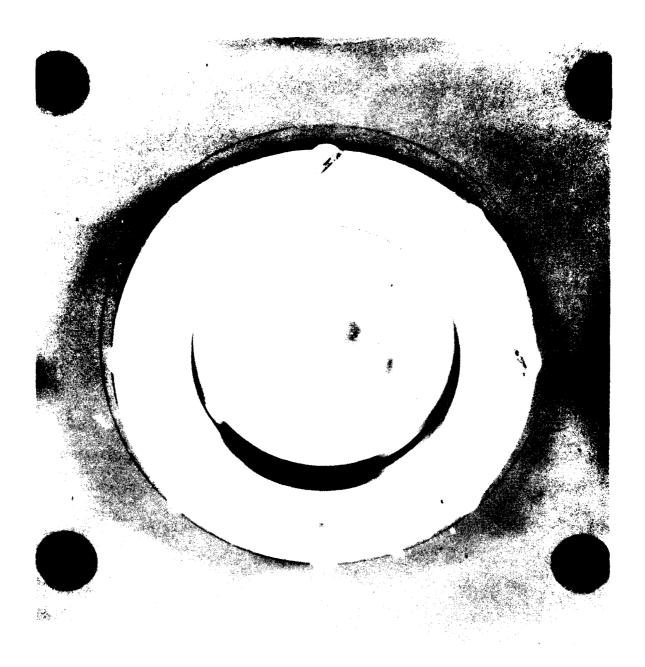
Figure 18. A specimen with the Optic Electronic XF 203 AR coating after four months of testing in San Diego Bay.

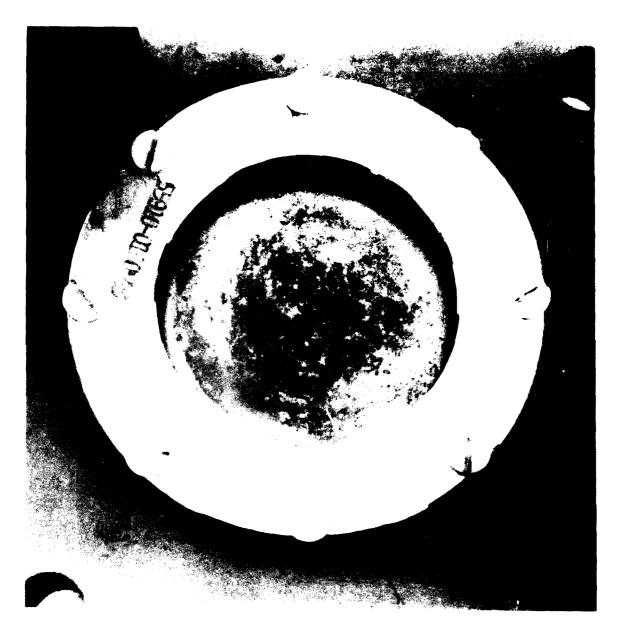
Figure 21. A specimen with the Optic Electronic XF 205 AR coating after two months of testing in San Diego Bay.

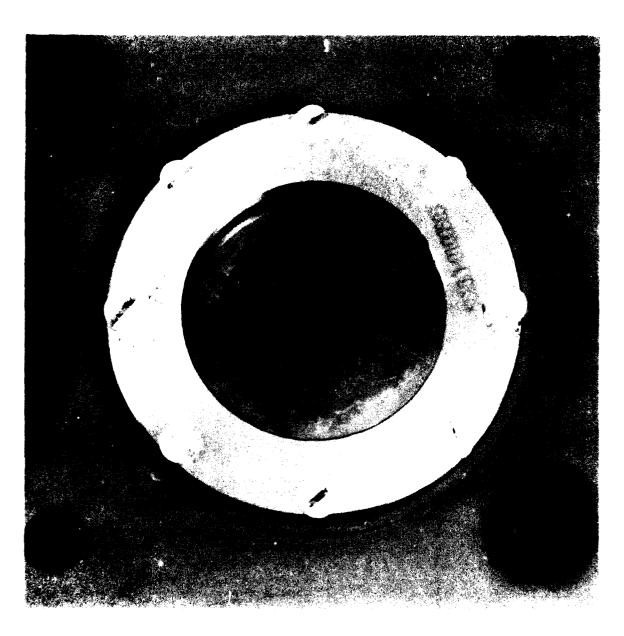
The two specimens with the Optic Electronic XF 205 coating were also discolored. They started to discolor within the first month near the centers of the specimens, and discoloration continued into the second month (figure 21). By the end of the third month, one of the specimens had a couple of pinpoint pits starting, and by the end of the testing period the specimens were discolored over 85 to 100 percent of their surfaces, and one of them had three or four small pits (figure 22).

Figure 22. A specimen with the Optic Electronic XF 205 AR coating after four months of testing in San Diego Bay.
